**TEARDOWN AND INSPECTION OF THE CUMMINS  
VTA-903 - EVALUATED USING THE SINGLE COMMON  
POWERTRAIN LUBRICANT (SCPL)**

**INTERIM REPORT  
TFLRF No. 450**

by  
**Adam C. Brandt  
Edwin A. Frame**

**December 2013**

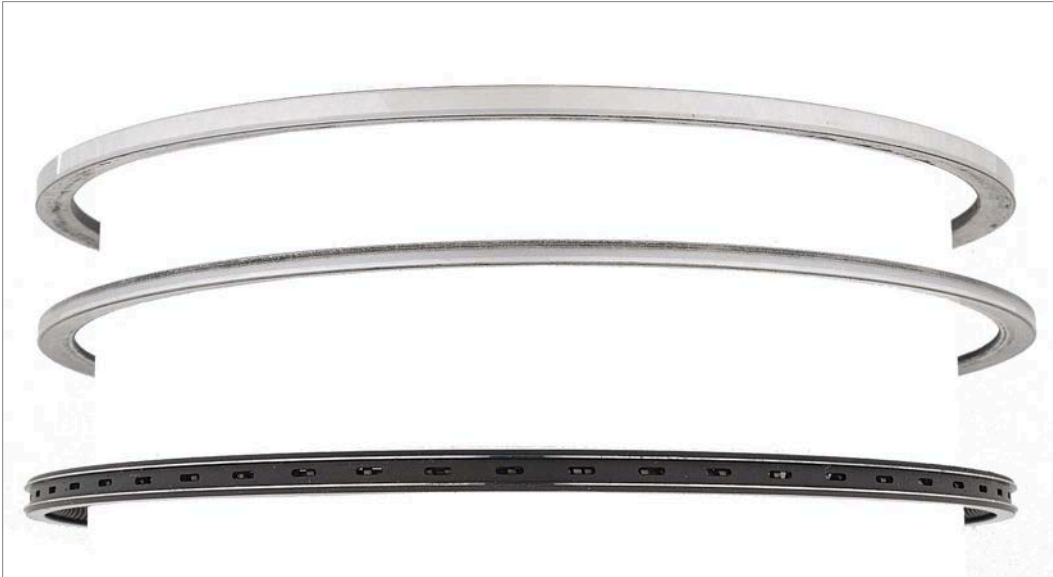
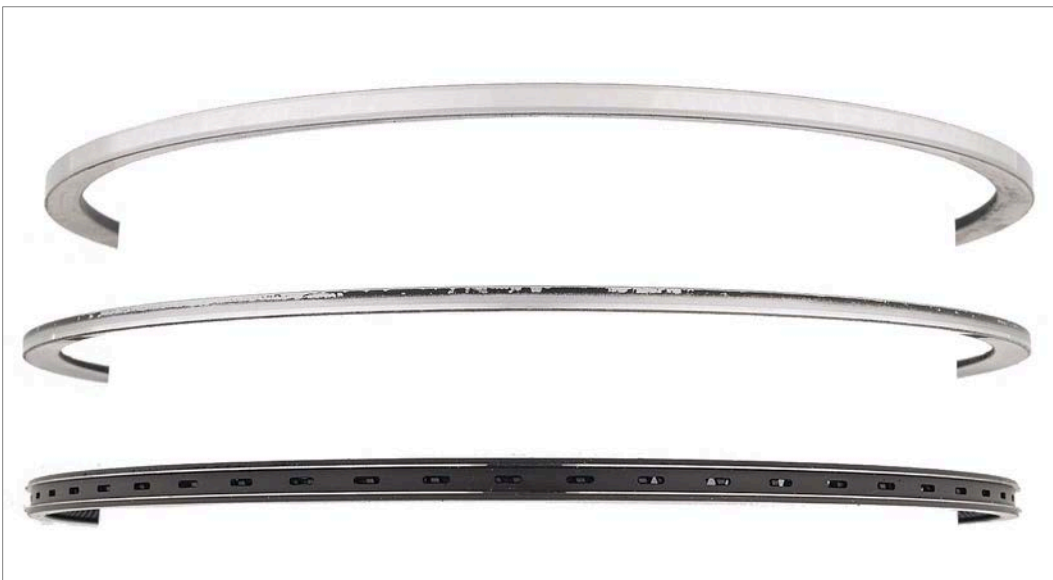
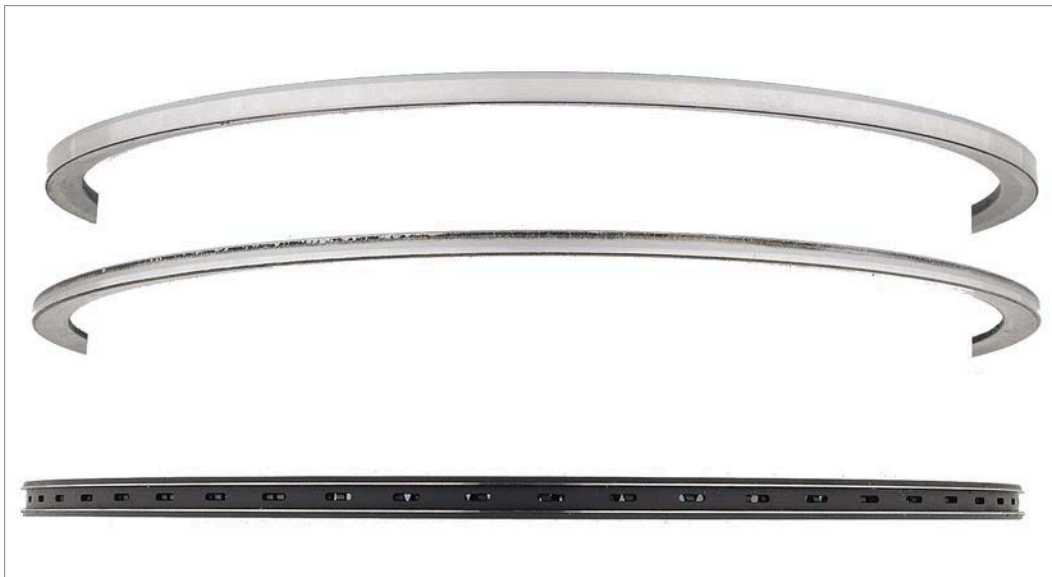
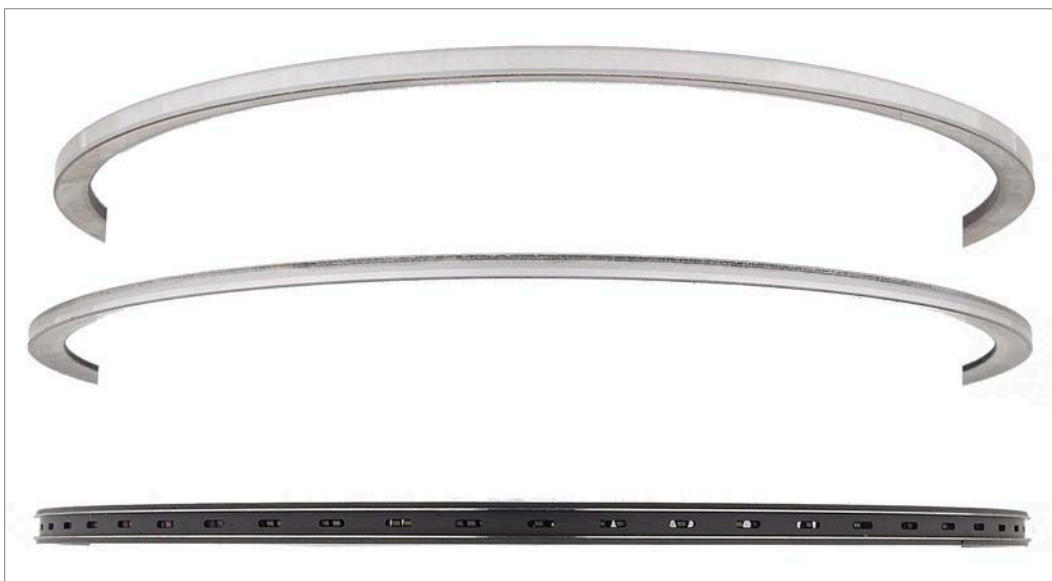
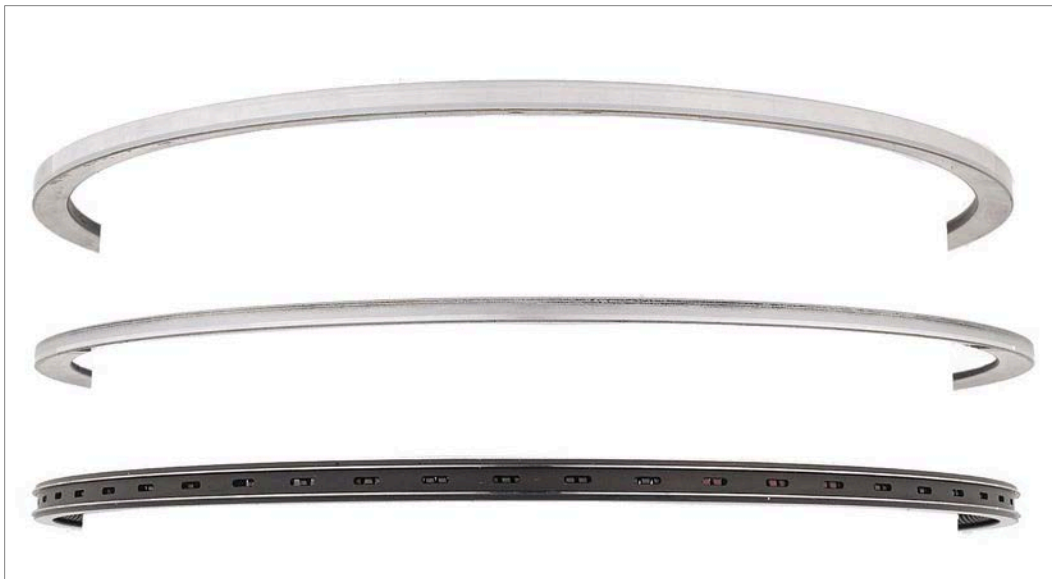
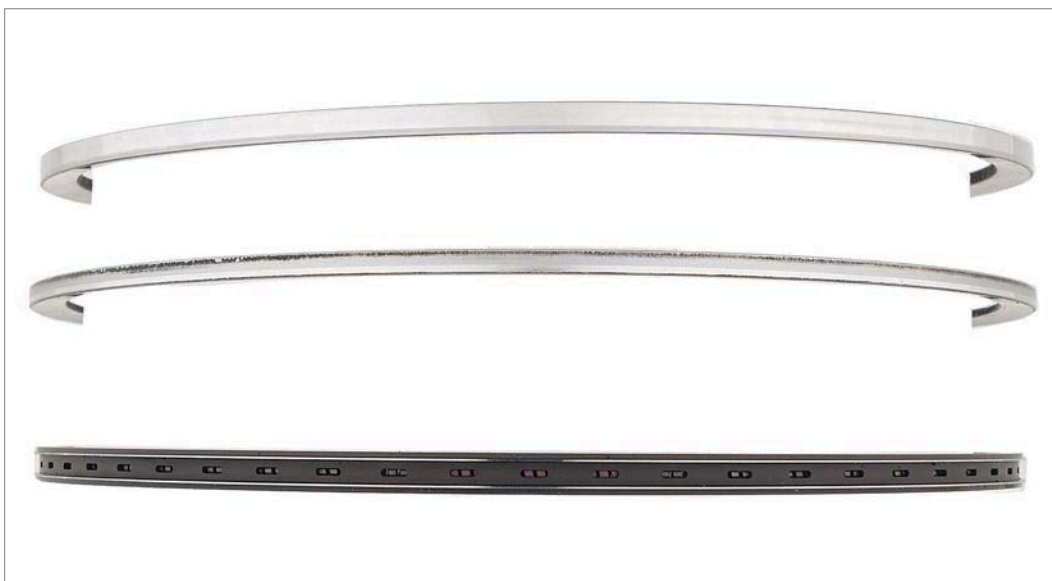
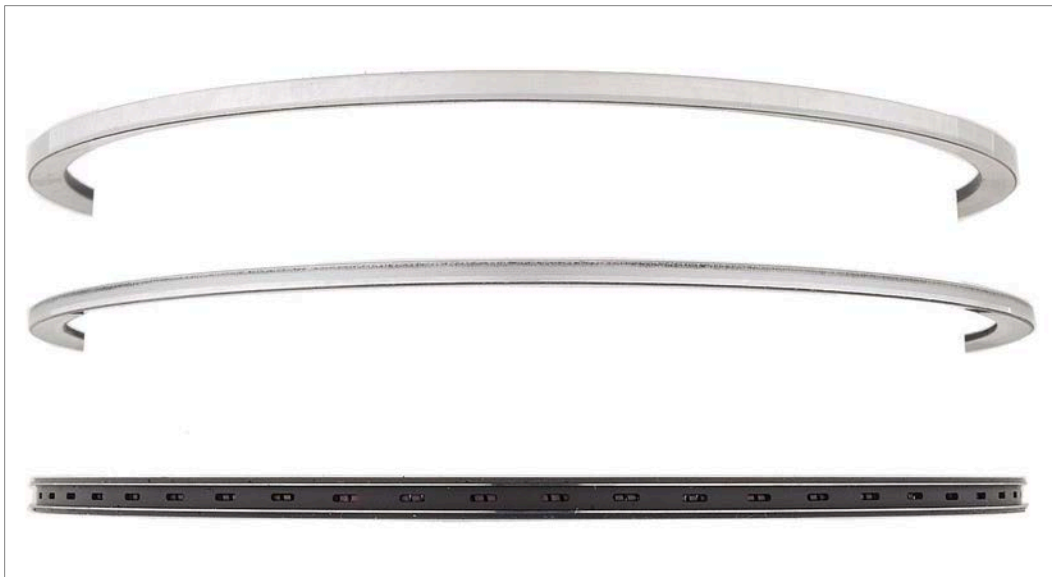
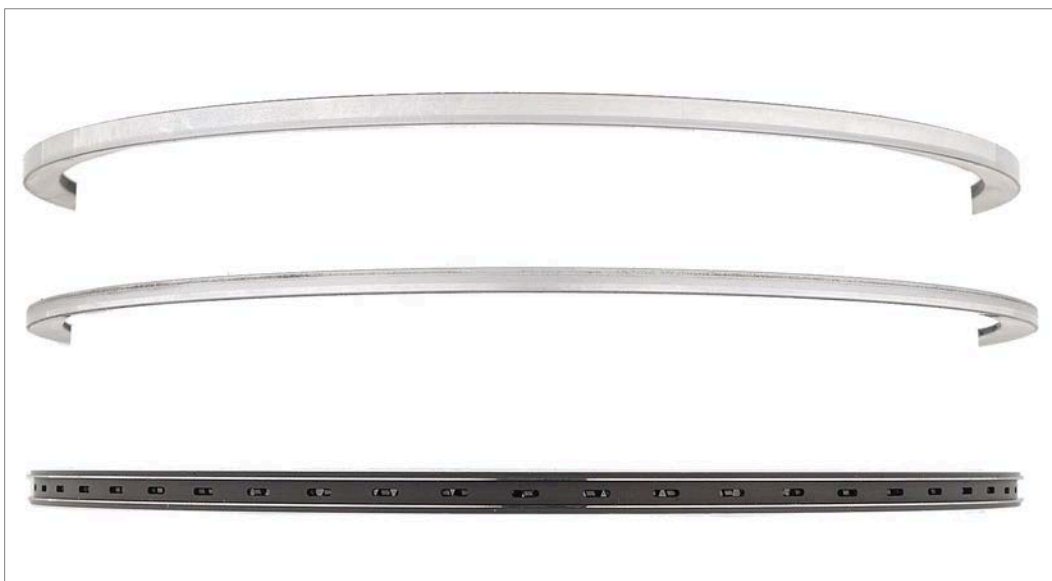
Ring pack measurements show the top (fire), second, and third (oil control) rings for each respective cylinder. No distress was noted for any ring packs removed from the engine, as shown in Figure 54 through Figure 61.

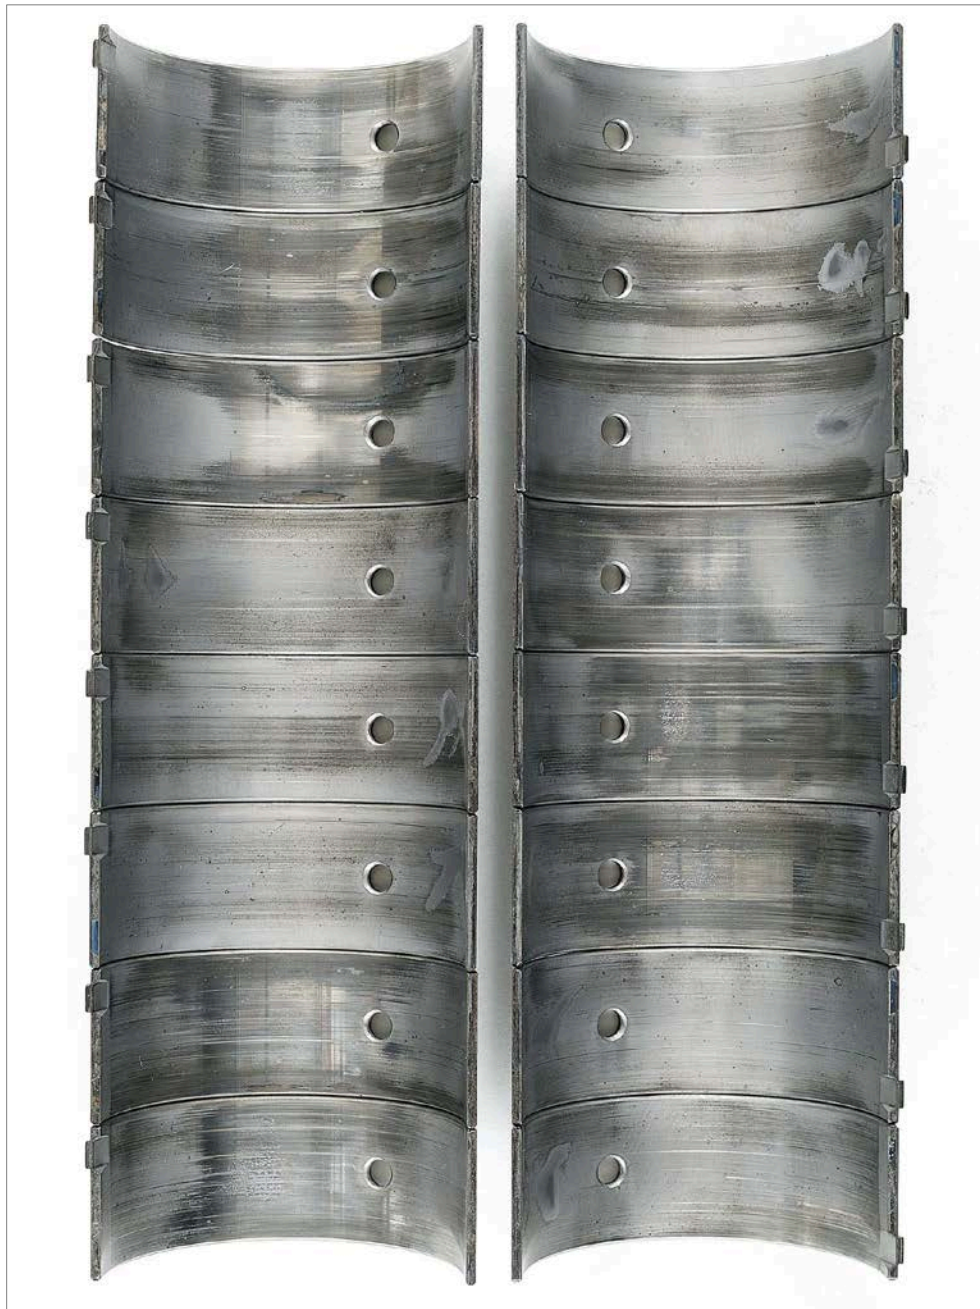
**Figure 62. Connecting Rod Bearings**

Orientation for connecting rod bearings is as follows: upper shell shown left, lower shell shown right, top to bottom cylinders 1 through 8. No shells showed exposed copper. Wear on all shells appears consistent with normal use, as shown in Figure 62.

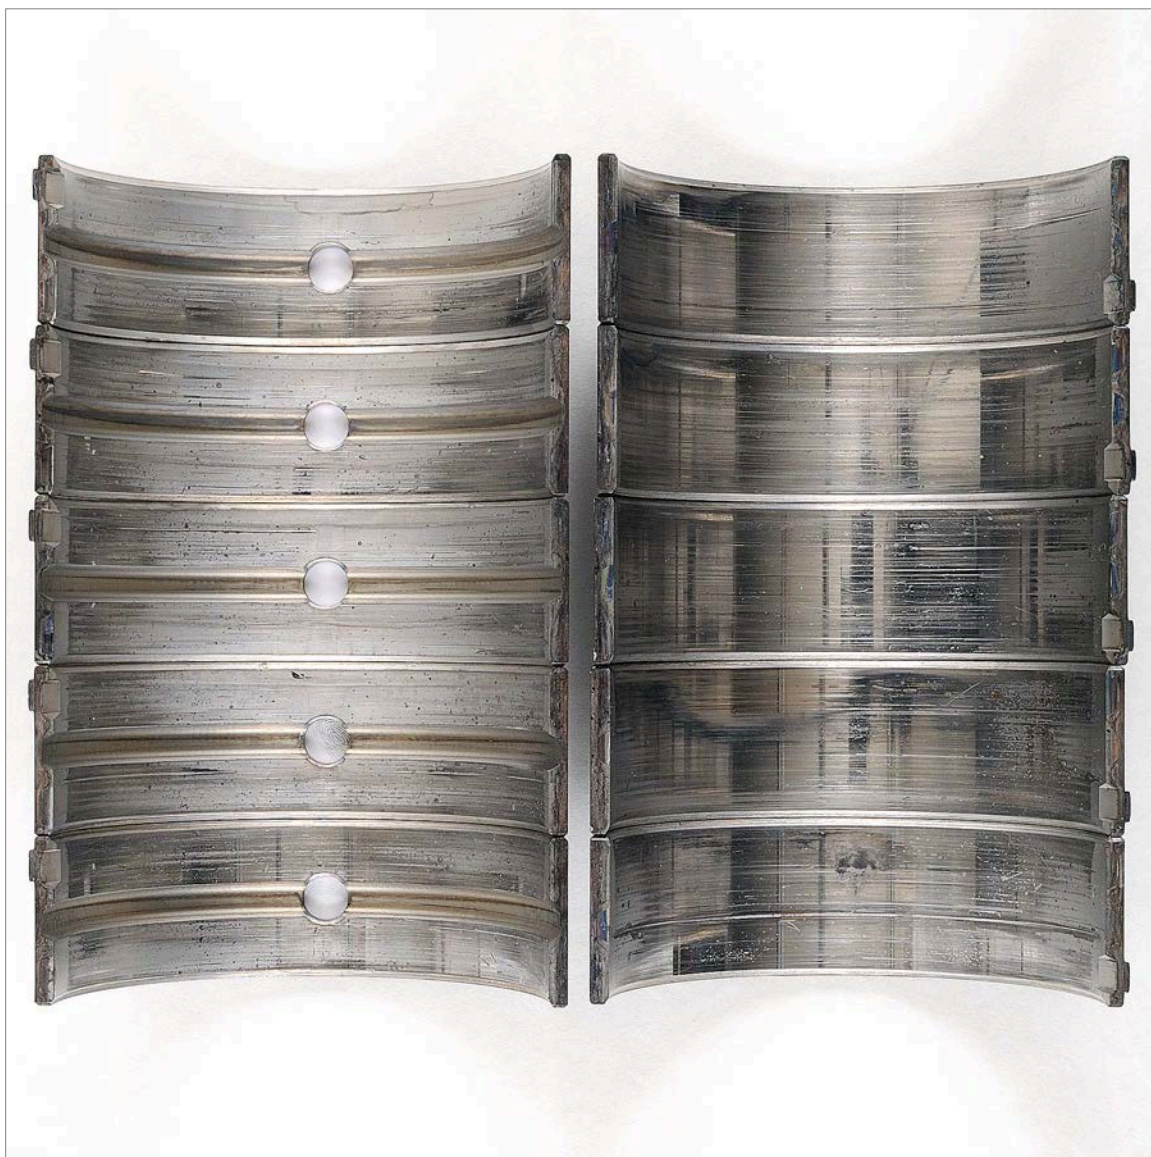
**Figure 63. Main (Crankshaft) Bearings**

Orientation for main bearings is as follows: upper shell shown left, lower shell shown right, journals 1 through 5 shown top to bottom (note: main bearing number 5 is at thrust location). As with the connecting rod bearings shown above, none of the main bearings showed any exposed copper. All markings present are consistent with normal use, as shown in Figure 63.

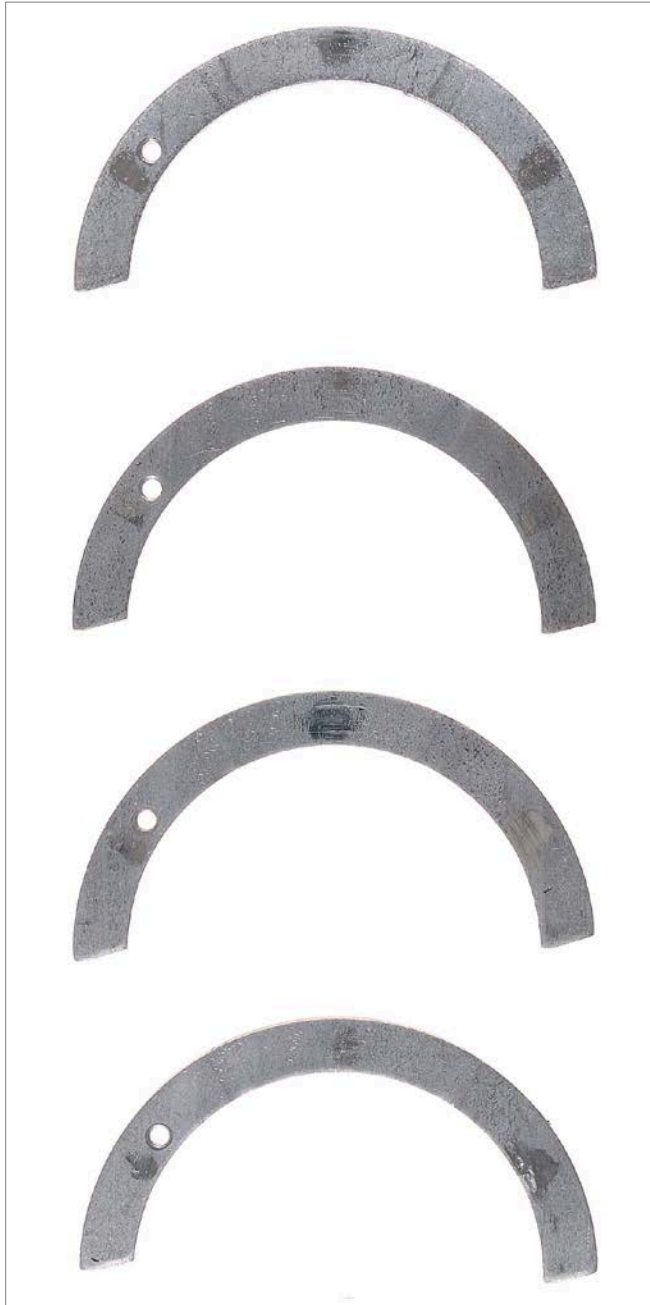
**Figure 64. Crankshaft Thrust Bearing Plates**

Orientation for crankshaft thrust bearing plates is as follows top to bottom: upper front, lower front, upper rear, lower rear. None of the thrust plates showed excessive wear, as shown in Figure 64.

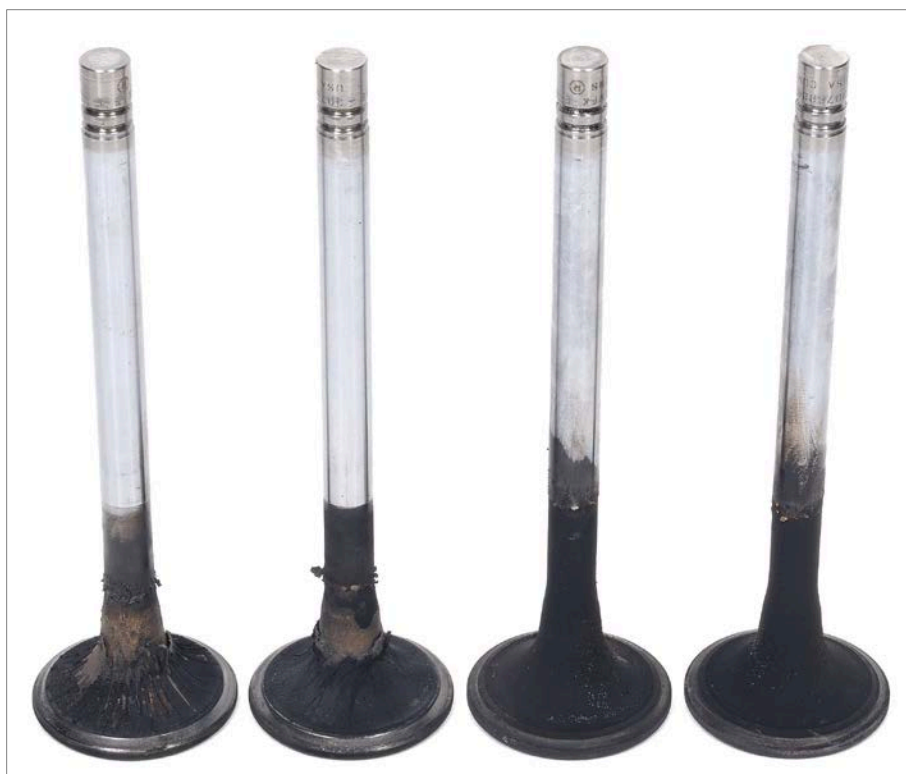
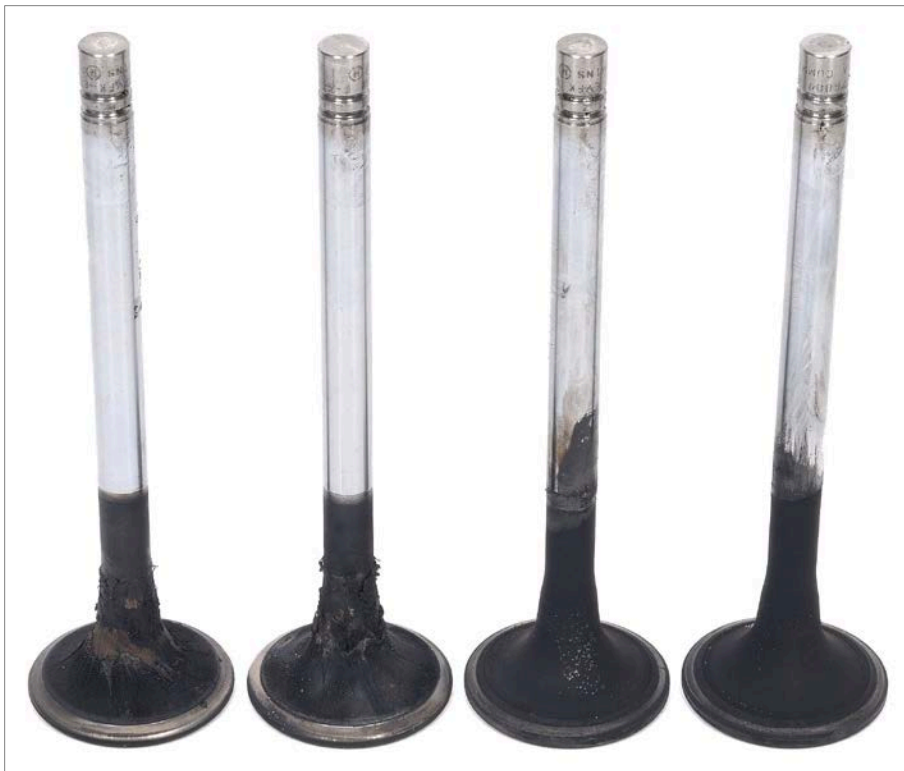
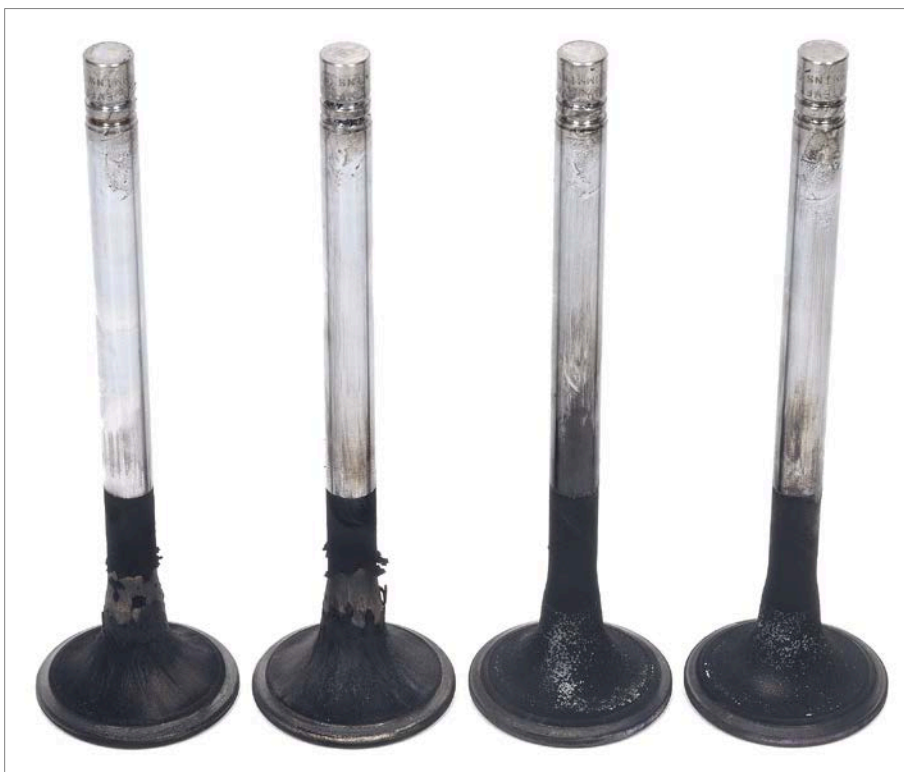
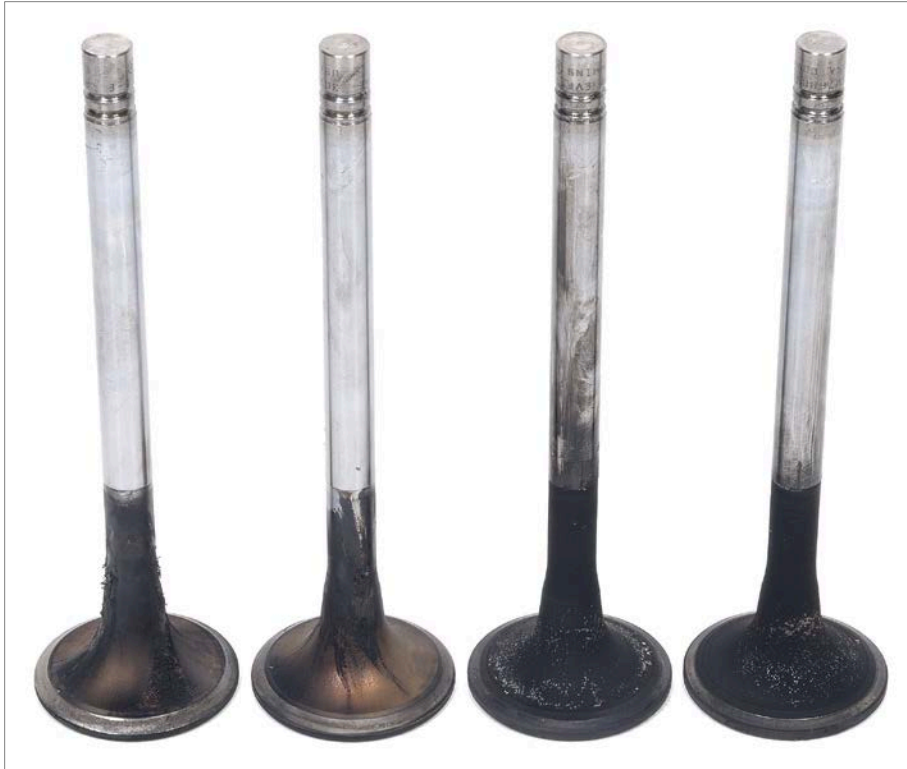
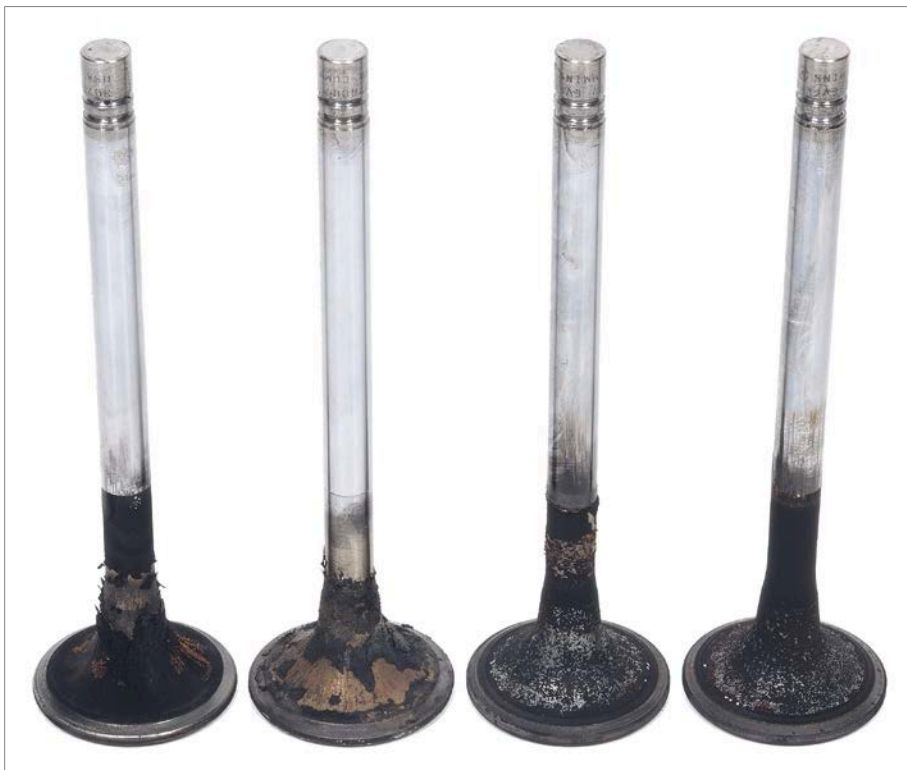
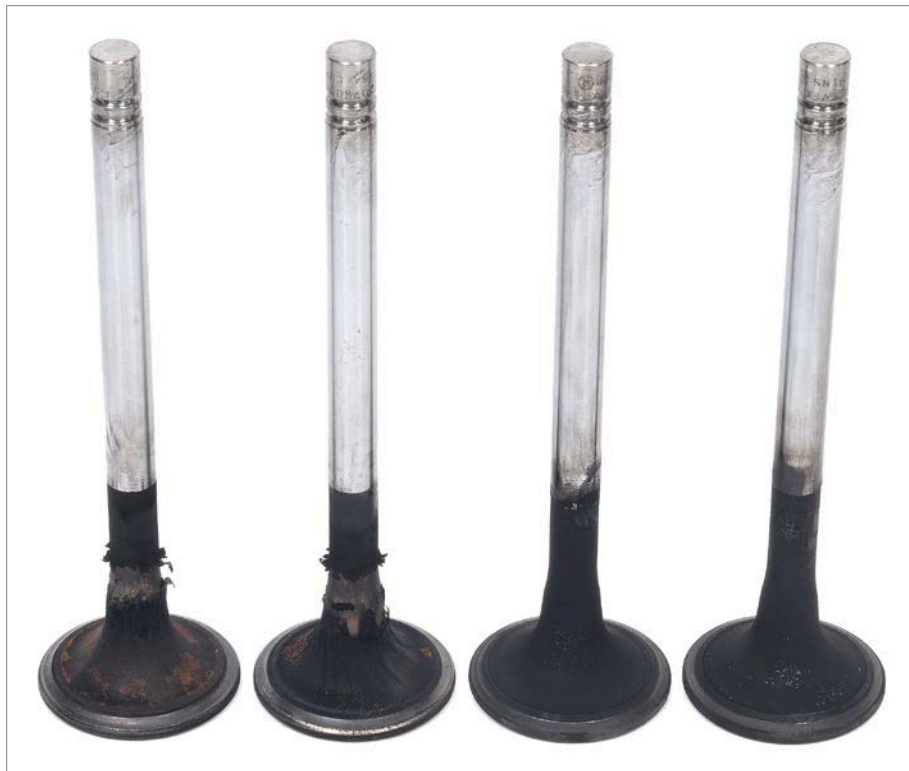
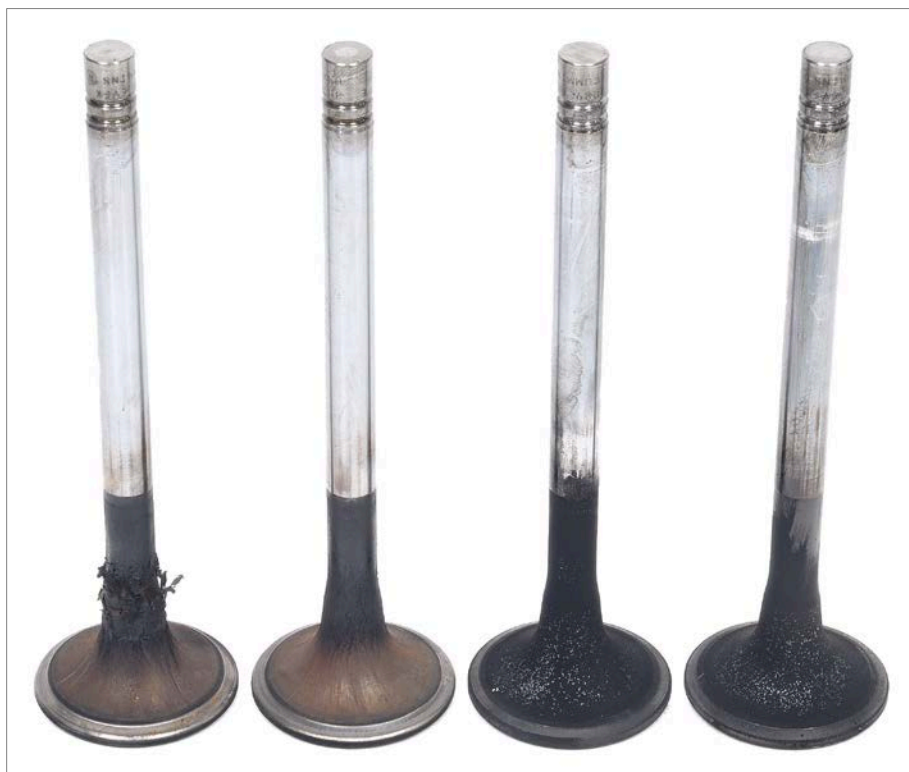
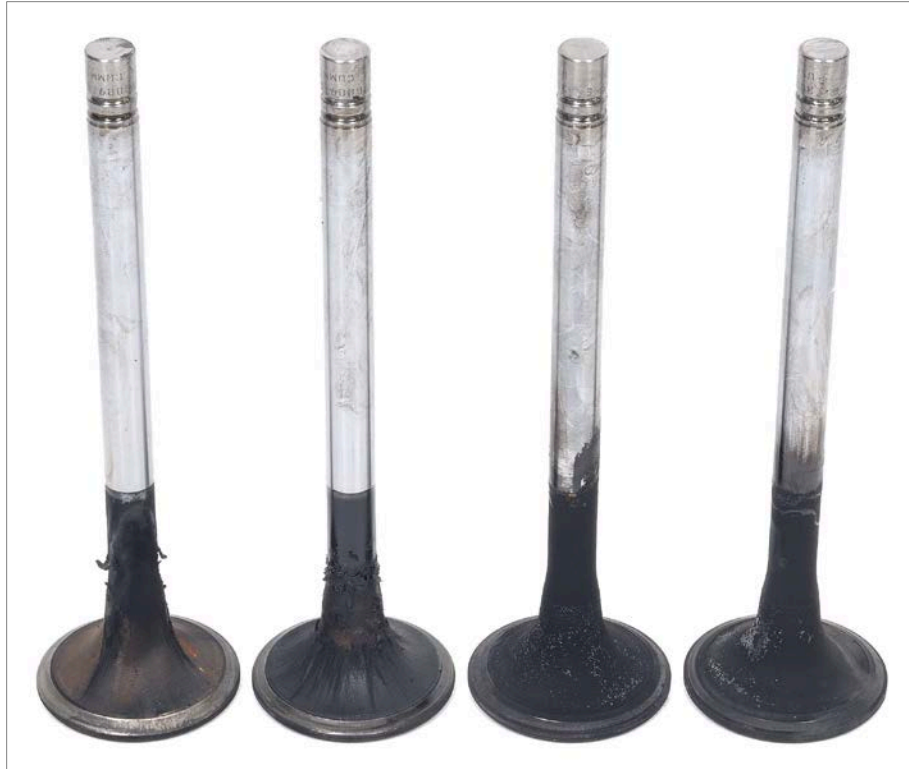
Valve orientation for all cylinders are shown as follows: intake left, intake right, exhaust left, exhaust right (Figure 65 through Figure 72). Several of the valve sets show the collection of the light flaked carbon deposits on the intake valves that did not fall off into the port area during storage and handling. These were previously described in the ratings section of the report. In all, the valves removed from the engine were found in good condition.

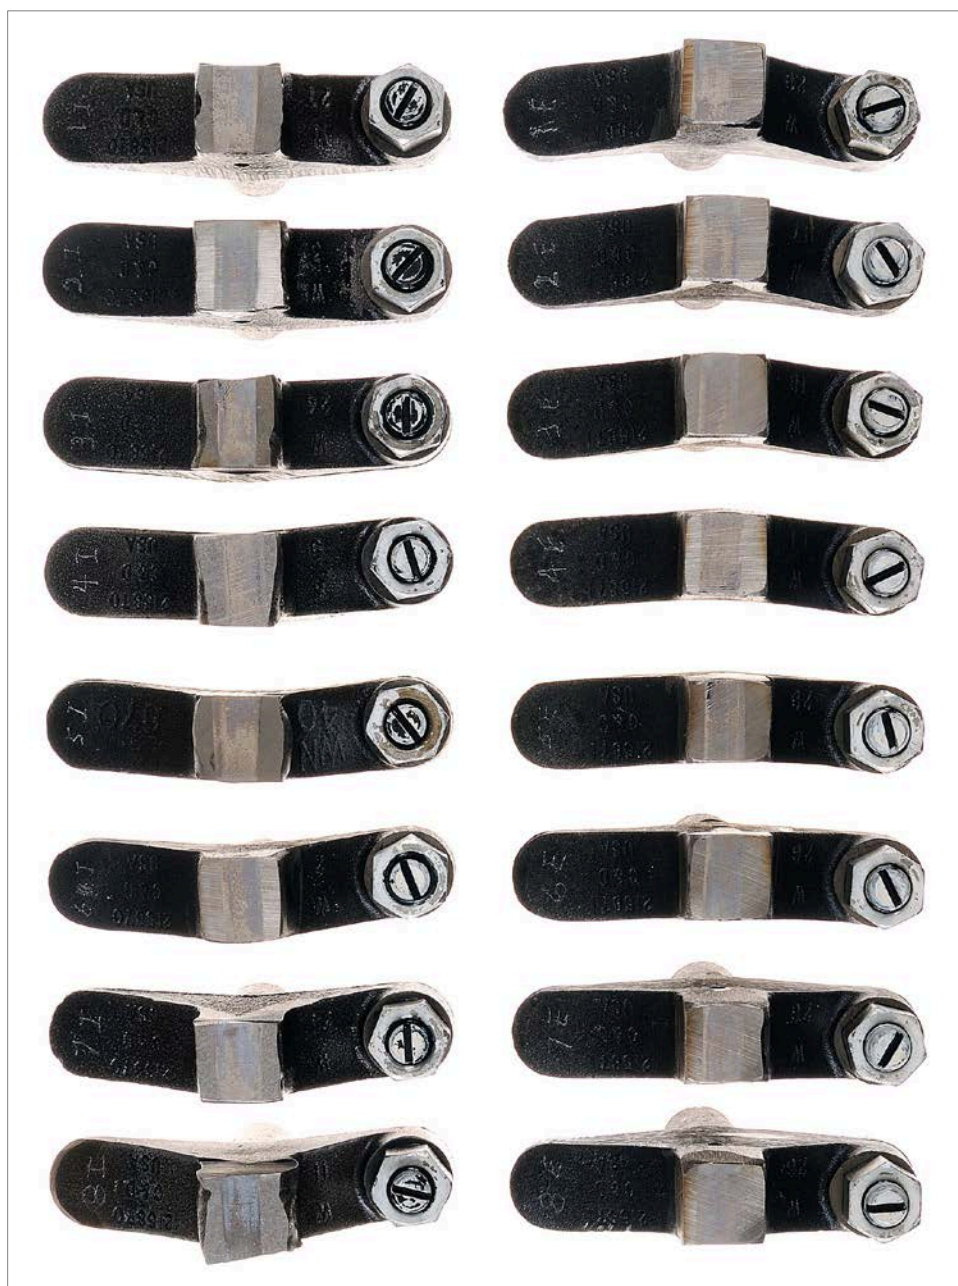
Figure 73. Intake & Exhaust Valve Cross Heads

The valve cross heads did show visual wear, which is consistent and normal for a used engine. This area is a known critical area for several engines in the Cummins engine family. Overall, the distress ratings ranged from a number 6 to number 8 rating, which coincides with a range of trace to light (8) and light to medium (6) distress. Trace distress is in general barely discernible, and can require a 10x magnification to fully assess condition. Light distress is more prominent, and can be seen without magnification, but is still much lighter than a medium, heavy, or catastrophic distress level. Full cross head ratings can be seen below in Table 21. Overall the condition of the cross heads was found to be good, and results suggest that the SCPL candidate provided adequate protection for this critical engine interface.

Valve cross head orientation is as follows: left column intake, right column exhaust, cylinders 1 through 8 top to bottom. The polished section at the center of the bridge was the area rated for distress, as shown in Figure 73. Although visible wear is noted, it was found to be normal, and below what would be considered critical.

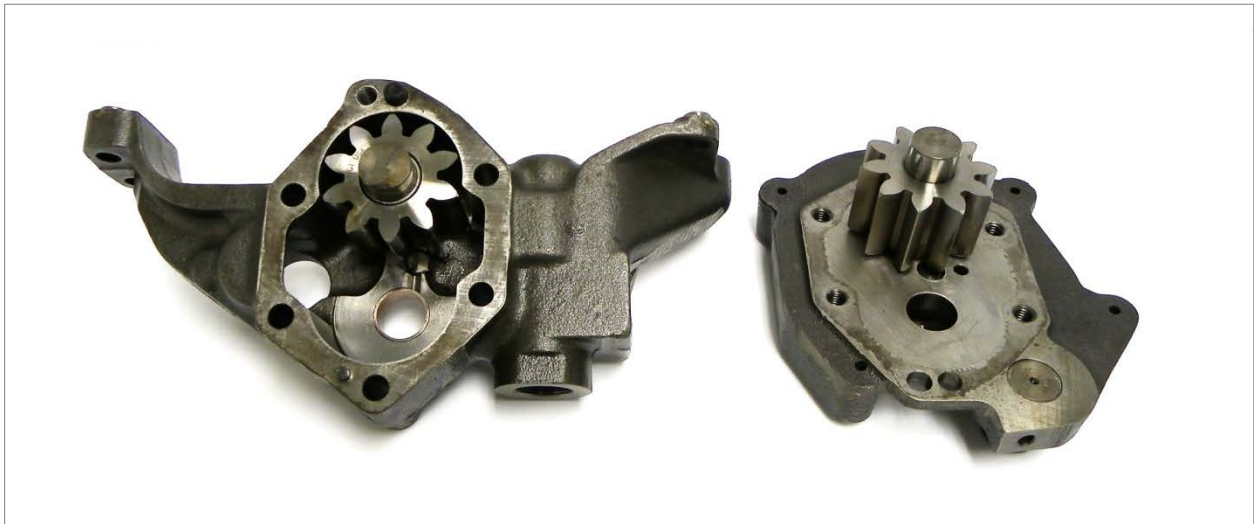
**Figure 74. Disassembled Oil Pump Assembly**

Starting with the oil pump, a visual external inspection was made of the oil pickup tube and oil pump drive gear assembly. No damage or blockage was noted at the oil pick-up, and no debris was present in the oil sump at the time of teardown to suggest supply blockage as a result. The oil pump drive gear showed to be in good visual condition, and the drive system appeared to be in good overall working condition showing smooth rotation and no excessive play. After the initial inspection was completed, the oil pump was then torn down to assess its internal condition. Figure 74 below shows the disassembled oil pump at inspection.

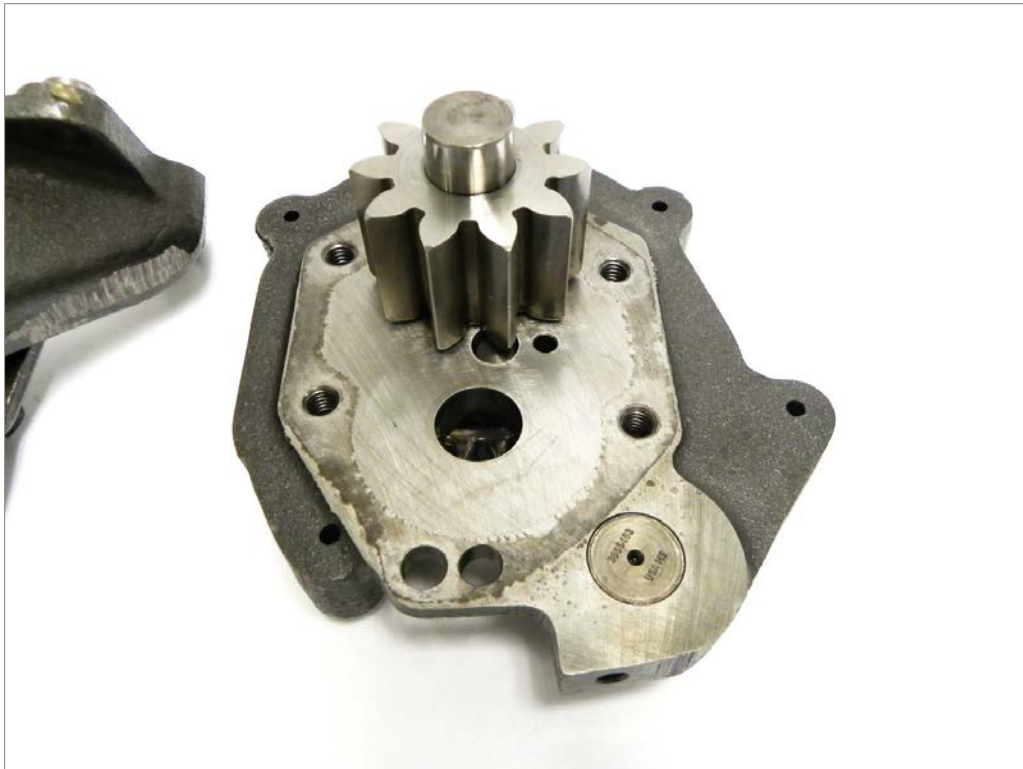
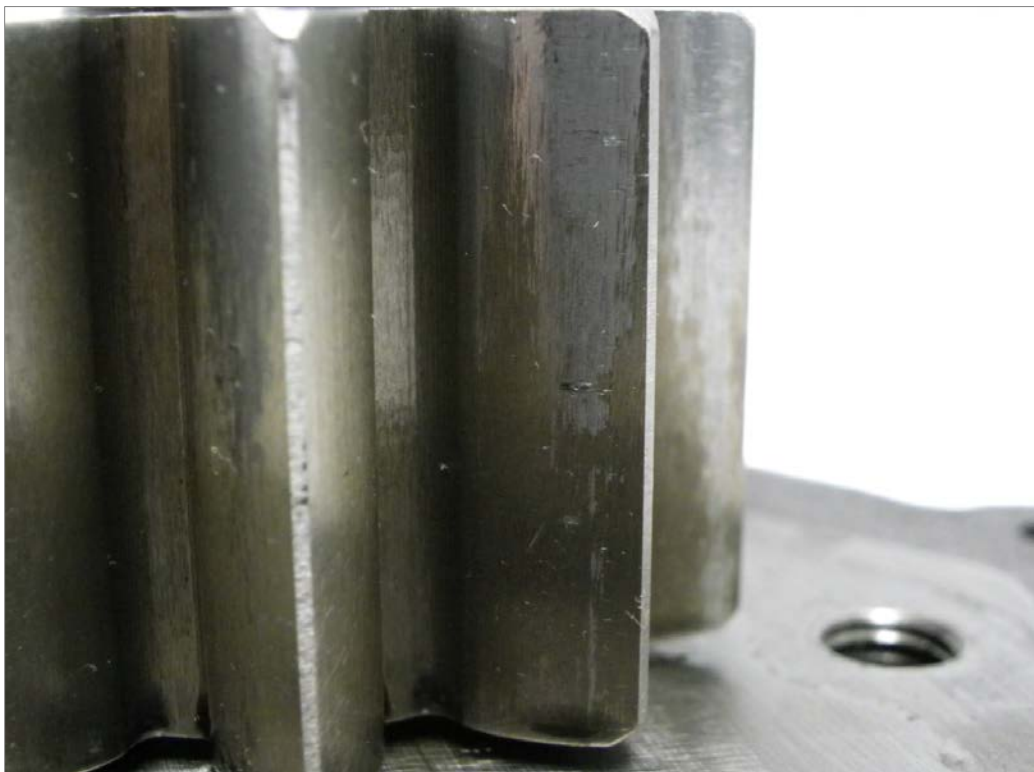
Figure 75 and Figure 76 on the following page show close up shots of the oil pump cover/drive gear condition. As seen in the photographs, no excessive wear or damage was present on the cover or gear teeth surface. Normal wear of the surface coating on the drive gear teeth was observed, but the overall condition of these components were normal, as expected from typical use.

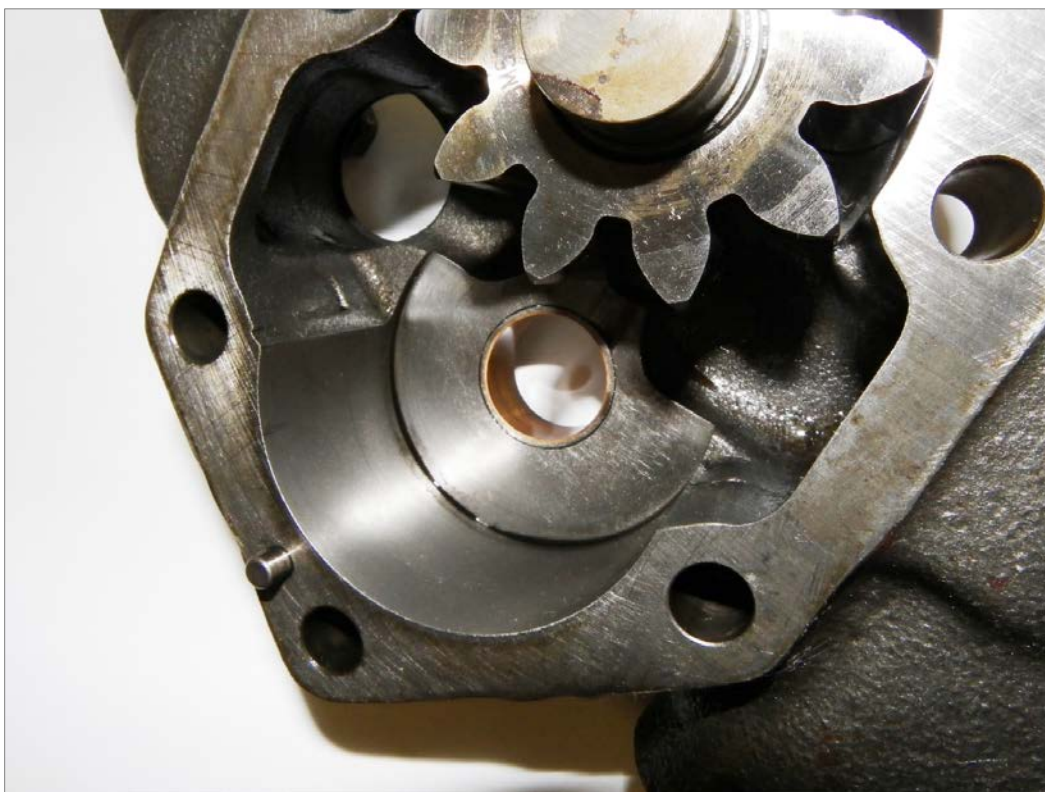
**Figure 77. Oil Pump Housing and Idler Gear**

Figure 77 below shows the remainder of the oil pump housing, and the oil pump idler gear that meshes with the drive gear shown above. Similar surface coating wear was seen on the idler gear complementing that seen on the oil pumps drive gear. The oil pump housing showed no signs of heavy wear, scoring, or polishing of the surface to suggest the oil pump attributed to the abnormal measurements observed during testing.

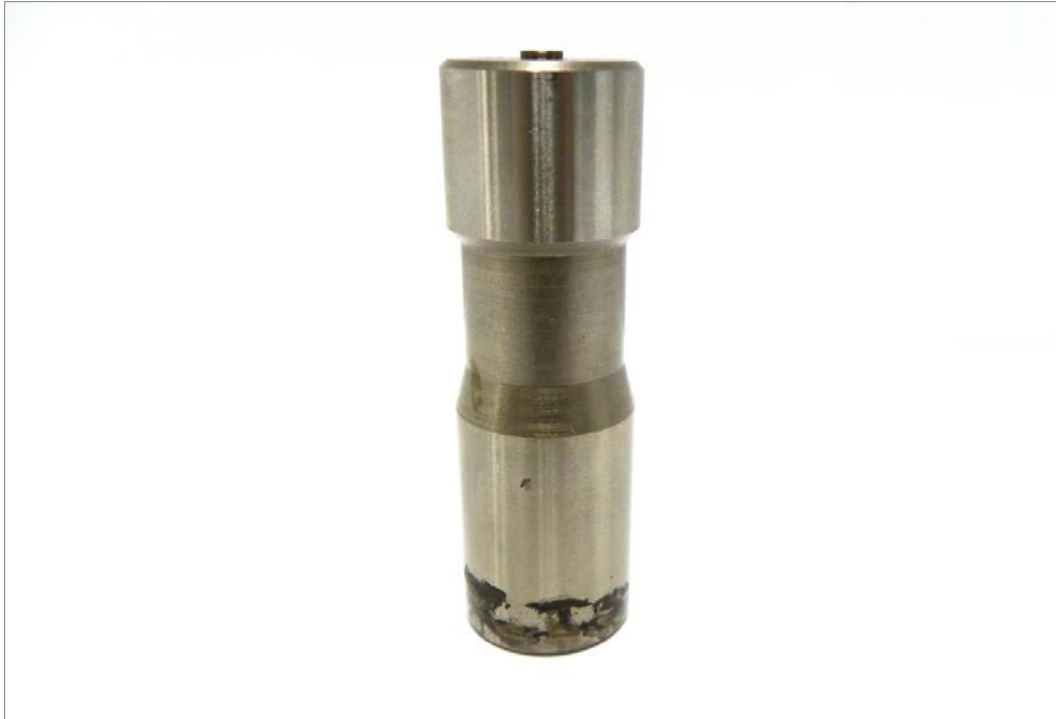
**Figure 78. Primary Engine Oil Pressure Relief Piston**

As seen in the photo, some wear was noted around the lower circumference of the valve. From previous experience of testing other similar Cummins engines at SwRI, wear in this area was somewhat expected and common. Although present, the valve did not show any signs of sticking upon removal, and failure of this particular valve in a sticking or no movement condition would not substantiate the trends observed by TARDEC. Since the trends observed during testing specifically showed a pressure drop AND flow increase at the same time, that suggested that the fault must have lied later in the lubricating system AFTER the point of measurement, as if the fault occurred prior to the point of measurement, oil pressure and flow would have been expected to have a direct relationship, not inverse as observed (i.e. pressure and flow would increase or decrease together). This knowledge, combined with the physical location of this valve

(immediately at the oil pump) ruled out any influence of the primary relief valve as a possible cause, leaving the secondary relief/bypass valve at the oil cooler as the next area for investigation.

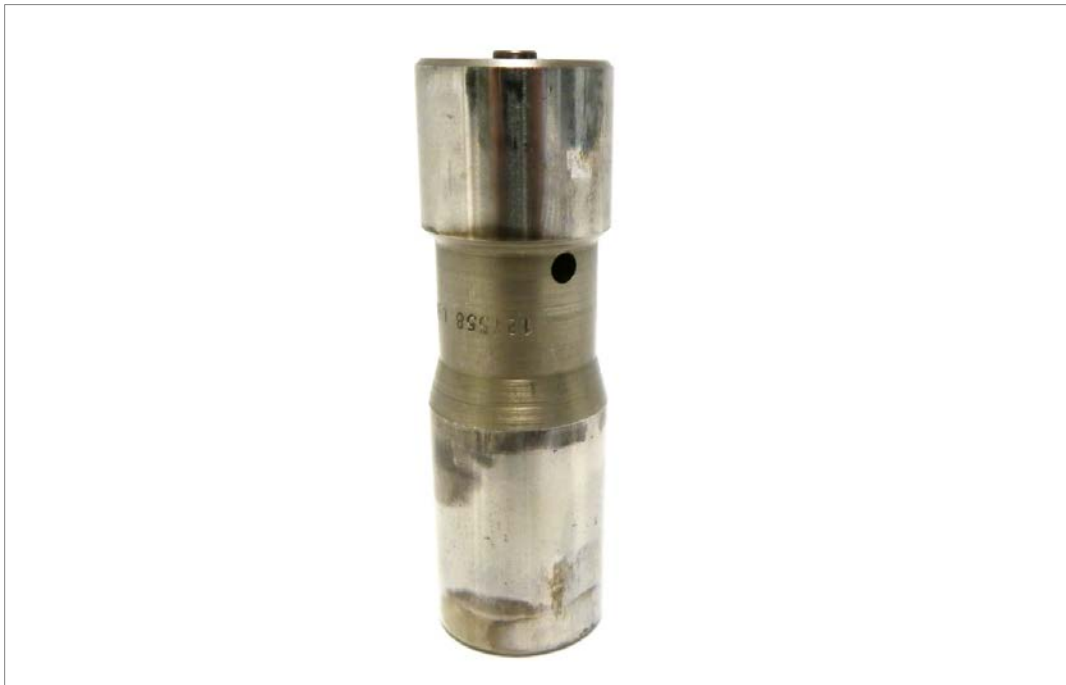
**Figure 79. Secondary Oil Pressure Relief/Bypass Piston (Oil Cooler)**

Immediately upon investigation of the secondary oil relief/bypass valve, difficulty was noted during its attempted removal from the valve body/bore that it sits in. After working with the assembly, the piston was eventually removed, and surprisingly appeared to be in slightly better condition at the surface than the primary valve seen at the oil pump. This valve can be seen below in Figure 79.

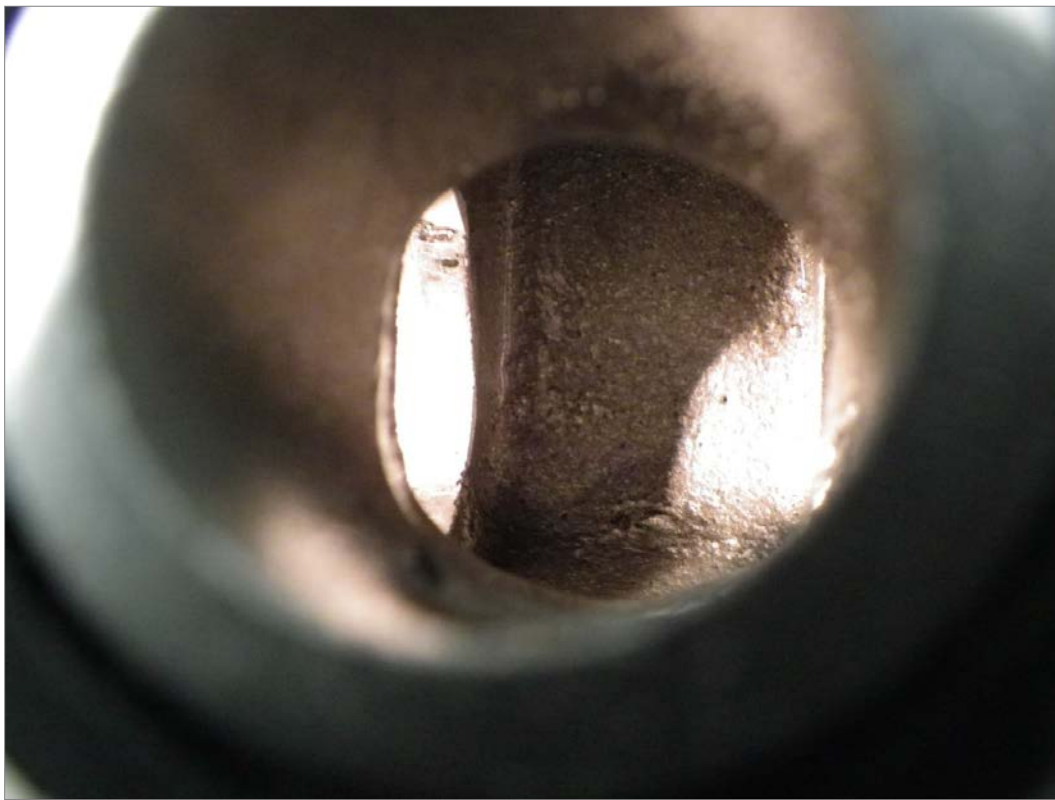
**Figure 80. Secondary Oil Pressure Relief/Bypass Valve Bore (Oil Cooler)**

After initial inspection, the valve and bore were cleaned and reassembled to further check the fit and movement of the piston within the bore it operates in. A very distinct resistance to movement was occasionally noted when the relief piston was slid up and down in the bore by hand. This resistance to movement was intermittent, and varied as the piston was moved up and down in the bore while also being slightly rotated by hand. A failure or resistance to movement of this particular valve would explain the erratic oil pressure and flow trends observed during

testing, assuming oil pressure and flow measurements were taken prior to this valve in the lubricating system. This is likely considering this valve's particular location on the engine is at/on the last external piece of hardware of the lubricating system on the engine (i.e. flow and pressure measurements would be expected prior to this point). After removing the valve, inspection of the bore surface was completed to assess condition. When inspected, damage was noted on one of the inner bore surfaces that the piston rides in, and is the likely cause for the intermittent movement of the relief piston. This damage can be seen below in Figure 80 (note, this area of the bore proved difficult to photograph, and the bulk of the bore surface washed out due to lighting. The damage noted can be seen near the very top of the ring on the left hand side of the hole being viewed through). This damage in the bore appears to be more consistent with tool damage from previous assembly or disassembly of this component, or could possibly be attributed to foreign object or debris that passed through the oil system and was lodged into the surface by the piston itself. Although the source of this damage is speculative, TFLRF feels this is the likely cause of the trends noted during operation.
